Full-Scale Fatigue Testing of a Wind Turbine Blade in Flapwise Direction and Examining the Effect of Crack Propagation on the Blade Performance

Othman Al-Khudairi ¹, Homayoun Hadavinia ^{1,*}

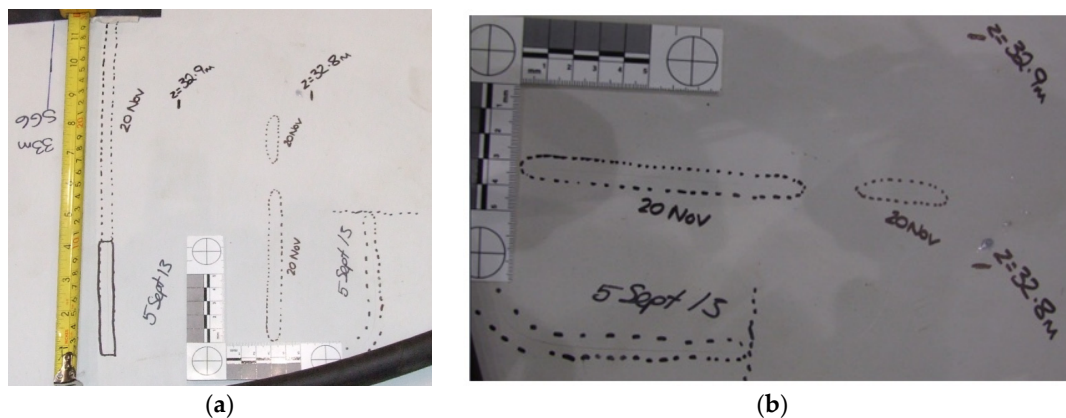
The test conditions and results for the blade with a 200 mm crack are shown in A pre-existing crack at around 32.96 m had extended by 190 mm in the middle of the blade as shown in Figure 13a with the overview image of the two cracks found. Figure 13b shows a close inspection of the new cracks found at about 32.83 m from the blade root which propagated for 110 mm and 40 mm on the middle cross section at this point. The next visual inspection was carried out after 39,934 cycles, where the applied BM value had been increased to 70% of the maximum target BM. The visual inspection showed an existing crack at about 32.96 m propagated 15 mm along the blade longitudinal direction at the TE midpoint. Finally, a visual inspection was made after 62,110 cycles and no further crack formation or propagation was observed and the induced crack stayed unchanged at its original length.

Table 4. Initially, a 2500 kNm bending moment at the root was applied which resulted in 1523 $\mu\epsilon$ at SG2. The strain at this location had increased from 1478 $\mu\epsilon$ before the insertion of crack, showing a 3% increase. A visual inspection was performed after 8063 cycles to check if any existing cracks had propagated or new ones formed. No changes to the existing cracks or to the 200 mm crack at 9 m distance were observed. Later on the visual inspection was repeated after 26,851 cycles. A pre-existing crack at around 32.96 m had extended by 190 mm in the middle of the blade as shown in Figure 13a with the overview image of the two cracks found. Figure 13b shows a close inspection of the new cracks found at about 32.83 m from the blade root which propagated for 110 mm and 40 mm on the middle cross section at this point. The next visual inspection was carried out after 39,934 cycles, where the applied BM value had been increased to 70% of the maximum target BM. The visual inspection showed an existing crack at about 32.96 m propagated 15 mm along the blade longitudinal direction

Figure 13. (a) Propagation of existing crack at 32.96 m after 26,851 cyclic loading; (b) Formation of hair line cracks at 32.8 m after 26,851 cyclic loading.

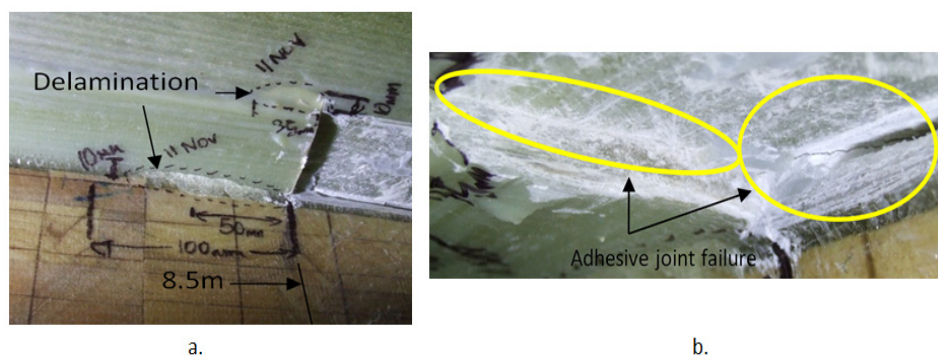
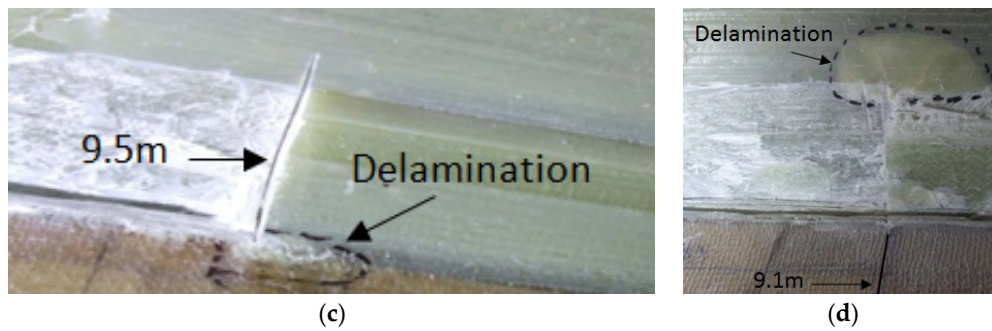
A visual inspection of the blade after 34,776 cycles showed a number of cracks was formed around the 1000 mm extended crack. Inside the web box at 8.5 m from the root, two delaminated areas each at 10 mm in width were detected. The delamination connected to the web had a delamination length of 83 mm and the delamination furthest away from the web had a length of 35 mm as shown in Figure 14a. At 8.5 m, the induced crack through the adhesive joint had propagated from its corner and extended through the plies causing delamination on the web lip, indicating that the crack plane has been deviated from its original path; see Figure 14b. At 9.5 m from the blade root delamination had occurred at the corner of the 1000 mm crack as shown in Figure 14c. Figure 14d shows delamination at 9.1 m at the location of the corner of the 200 mm crack. The fact that the crack bridged across from the unreinforced adhesive to shear web laminate is interesting, and is probably a result of the complex mode II loading that would be induced by a flapwise test in this region. It is also possible that when cutting the crack the blade had travelled into reinforced material as well as through the adhesive, which would make the bridging more likely to occur.

Figure 14. Damaged areas around the root: (a) delamination at 8.5 m (b) adhesive joint failure at 8.5 m; (c) delamination inside the web box at 9.5 m and (d) delamination inside the web box at 9.1 m.

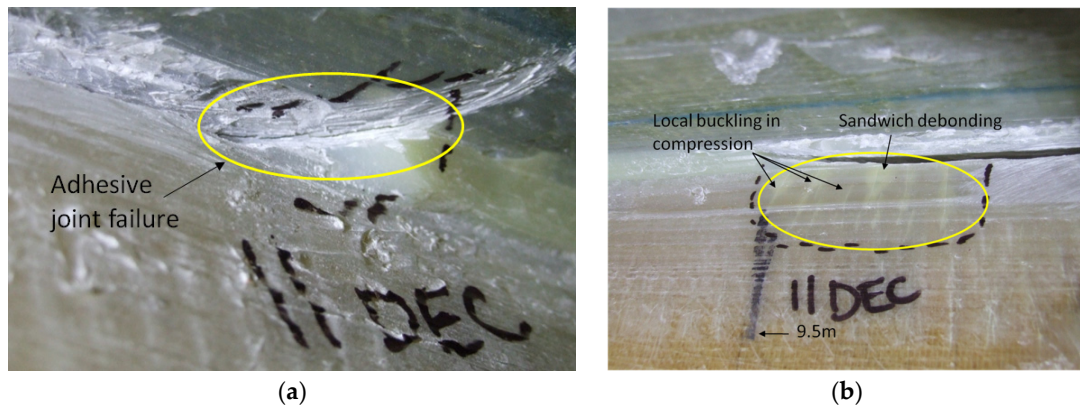
The adhesive joint had debonded outside the web box at 8.5 m as shown in Figure 15a indicating that the crack had propagated all the way through the web. At 9.5 m the blade experienced multiple local buckling under compression, and debonding in the sandwich propagated into the web, as shown in Figure 15b.

Figure 15. (a) Adhesive debonding outside the web box at 8.5 m; (b) local buckling under compression and sandwich debonding outside the web box at 9.5 m.

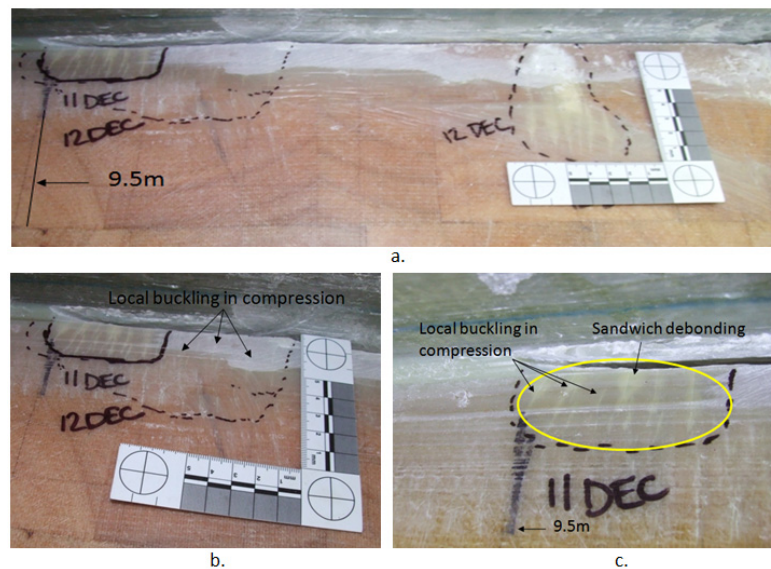
Figure 16a shows outside the web box at 9.5 m with an overview of the damaged areas. The blade experienced multiple local buckling under compression, and sandwich debonding going into the web. Figure 16b is the magnified view of the damaged area at 9.5 m and Figure 16c shows the magnified view of the damaged area at 9.3 m. The crack had also propagated 100 mm in the adhesive joint at 8.5 m.

Figure 16. Outside web at 9.5 m (a) overview of local buckling under compression and sandwich debonding (b) magnified view of damage at 9.5 m (c) magnified view of damage at 9.3 m.

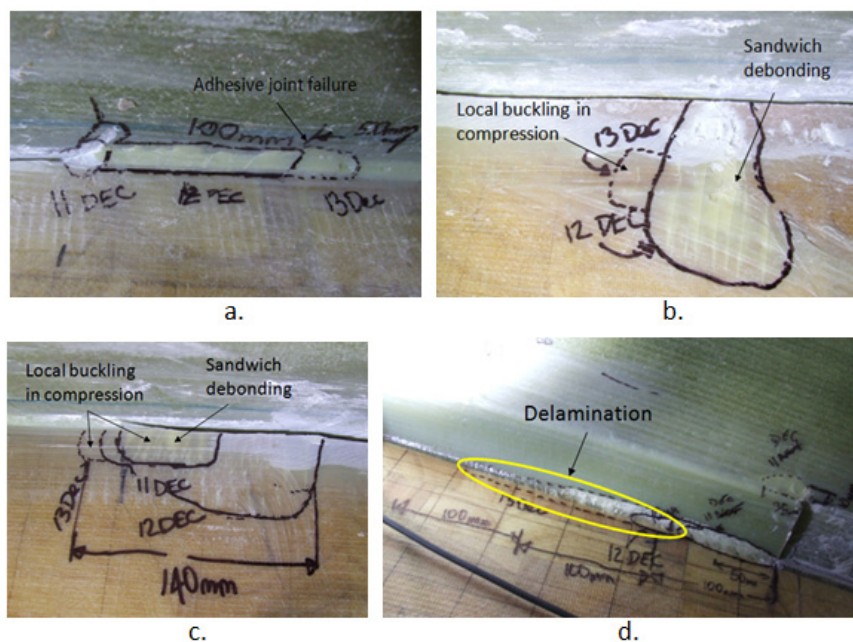
A visual inspection of the blade after 56,762 cycles showed that many of the cracks had extended along the web within the 1000 mm crack area as illustrated in Figure 17. At 9.5 m inside the web some delamination had also begun to occur.

Figure 17. Crack propagation within the web; (a) adhesive joint failure outside the web; (b,c) local buckling under compression outside the web; (d) delamination inside the web.
