Johnson, R.M. and Warburton, J. (2015) 'Sediment erosion dynamics of a gullied debris slide: a medium-term record' *Catena*, 127 (April), pp. 152-169.

Sediment erosion dynamics of a gullied debris slide: a medium-term record

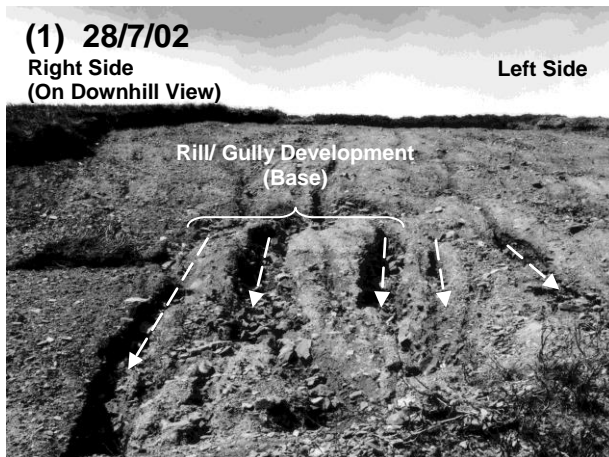
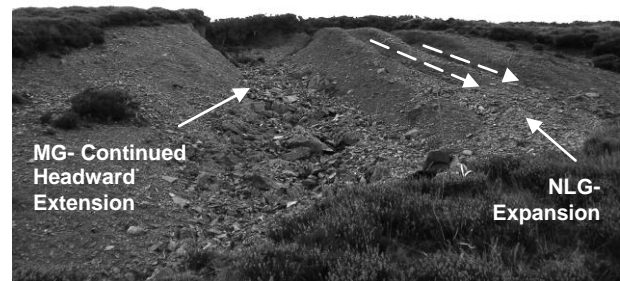
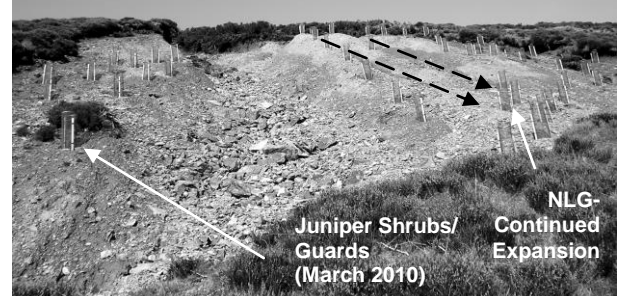
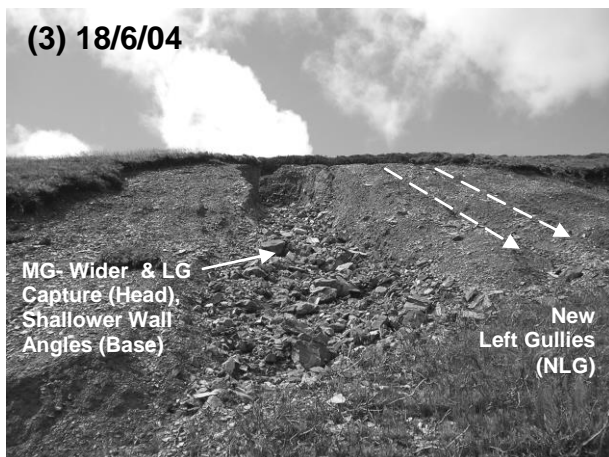
Fig 3

intervals ranging between 15 and 812 days (Figure 3 shows key images). Incision began soon after the exposure of the scar area; being well established by 17 June 2002. Initial development involved the formation of multiple ($n=6$), linear and parallel rills/ gullies. Between August 2002 and April 2003 significant expansion of the rill network occurred, creating one main gully. The headward erosion of the main gully captured the drainage channel, thereby re-directing all the flow from drainage channel to Wet Swine Gill via the slide scar (Figure 1 C). The morphology of the main gully remained relatively stable until at least January 2004, although by June 2004 significant widening at the gully head and a reduction of the gully wall angles towards the base of the eroded hillslope were observed. Following deliberate permanent blocking of the drainage channel at the head of the slope (18-21 July 2004), gully development slowed with only minor widening and a small reduction of gully wall angles. By March 2008 (and thereafter) continued headward recession in the vicinity of the drainage channel, resulted in undermining of the former drainage channel bed and undercutting of the adjacent hillslope as shown by the overhanging vegetation.

Post-failure activity beyond the main gully was initially less marked, but became more prominent by 2008. The 'left gullies' (Figure 3) can be grouped into two sets, firstly shallow forms which existed prior to June 2004 and were captured by the widening of the main gully and; secondly, two gullies which developed nearer the scar edge ('new left gullies' in Figure 3), fed by runoff from the upper hillslope. By March 2008 these gullies transferred sediment beyond the scar

perimeter, with coarse sediment eventually coupling with Wet Swine Gill (first observed in July 2012). Furthermore, ongoing interfluvial lowering between them (Figures 3 and 4), may in time result in the capture of gully L1 by gully L2. These may also eventually merge with the main gully, triggering a new phase of activity.

communication). Figure 3 (photos 7 & 8) shows subsequent widespread loss/tilting of the plastic nursery guards installed around the Juniper shrubs. By 30 July 2014, 39% of nursery guards had failed and only 30% of the planted shrubs were established. Furthermore, following February 2014, under a 2013 Higher Level Stewardship Agreement, the Caldbeck Commoners Association, LDNPA and Natural England, have planted 500 native trees on hillslopes adjacent to the Wet Swine Gill stream, with 64 immediately downslope of the scar (Barron, 2014, personal communication; Planning Inspectorate, 2014). Additional works are planned for later in 2014, including a temporary fence enclosure (consented for 15 years) around the failure scar (Barron, 2014, personal communication); this is part of a wider initiative in the Caldbeck Fells to reduce sediment transfer and improve water quality (Planning Inspectorate, 2014).

Table 1 and Figure 4 show the growth of the main gully (as also outlined in Figure 3). Based on these data, four key observations stand out; firstly, between August 2002 and June 2003 a rapid transition of main gully size and shape occurred. Gully area percentage change ($\% \Delta$, as defined in Table 1) increases at the two cross sections, ranging 105% (0.68 to 1.39 m²) to 797% (0.21 to 1.84 m²). This enlargement is dominated by vertical incision (e.g. 0.16 to 1.47 m at top cross section) accompanied with minor lateral growth (e.g. 2.10 to 2.20 m at base cross section). As a consequence, width-depth ratios reduce markedly; for example, at the top cross section from 17.8 to 1.4. Secondly, between June 2003 and March 2004, change was much less rapid and lateral expansion of the main gully became more important than vertical incision; where gully-top width percentage changes for the top and base of scar cross sections are: 125% (2 to 4.5 m) and 59% (2.2 to 3.5 m) respectively, contrasting depth changes of 12% (1.47 to 1.64 m) and -2% (0.9 to 0.88 m) respectively. Thirdly, following 2004, changes at the top cross section slowed considerably. Here, gully width increased from 4.50 m in 2004 to 5.35 m in 2012, with percentage change between successive surveys being generally less than 10%; an accompanying trend towards sediment infilling is reflected in reducing depths (1.64 m in 2004 to 1.42 m in 2013) and reducing area following a peak size of 4.80 m² in 2009 to 4.23 m² in 2013. The gully shape in this period showed relative stability where width-depth ratios are low and evolving from around 3 to 4. Fourthly, the main gully in the base cross section in the period following 2004, has constantly increased in width but with diminishing magnitude of percentage change: 49% (2004-2010), 8% (2010-2012), 1% (2012-2013); an

However, the wider applicability of this self-stabilisation model has been questioned. Bocco (1991) suggests that it implies an over reliance on fluvial processes, and it assumes the re-establishment of vegetation. Whereas Parkner et al. (2006) suggest these models are not always suitable, as they describe a simple uni-directional development with no intervening periods of inactivity before final stabilisation. For example, in the context of gullying in the Waiapu basin, in New Zealand, between 1939 and 2003, they detail multiple phases of gully expansion (up to 18 years) and inactivity (up to 14 years), reflecting the episodic occurrence of major storms and shifting topographic thresholds in association with land use changes. Burkard and Kostaschuk (1997) also suggest that growth may continue; they provide the example of gullies adjoining the Lake Huron shoreline (Canada), where larger gullies have continued to grow by capturing smaller adjacent gullies. The medium-term monitoring data at Wet Swine Gill (Figures 3 & 4 and Tables 1 & 2) provide evidence in support of both the characteristic evolutionary model, but also periodic main gully growth via the capture of smaller adjacent gullies (Figures 3 & 4).

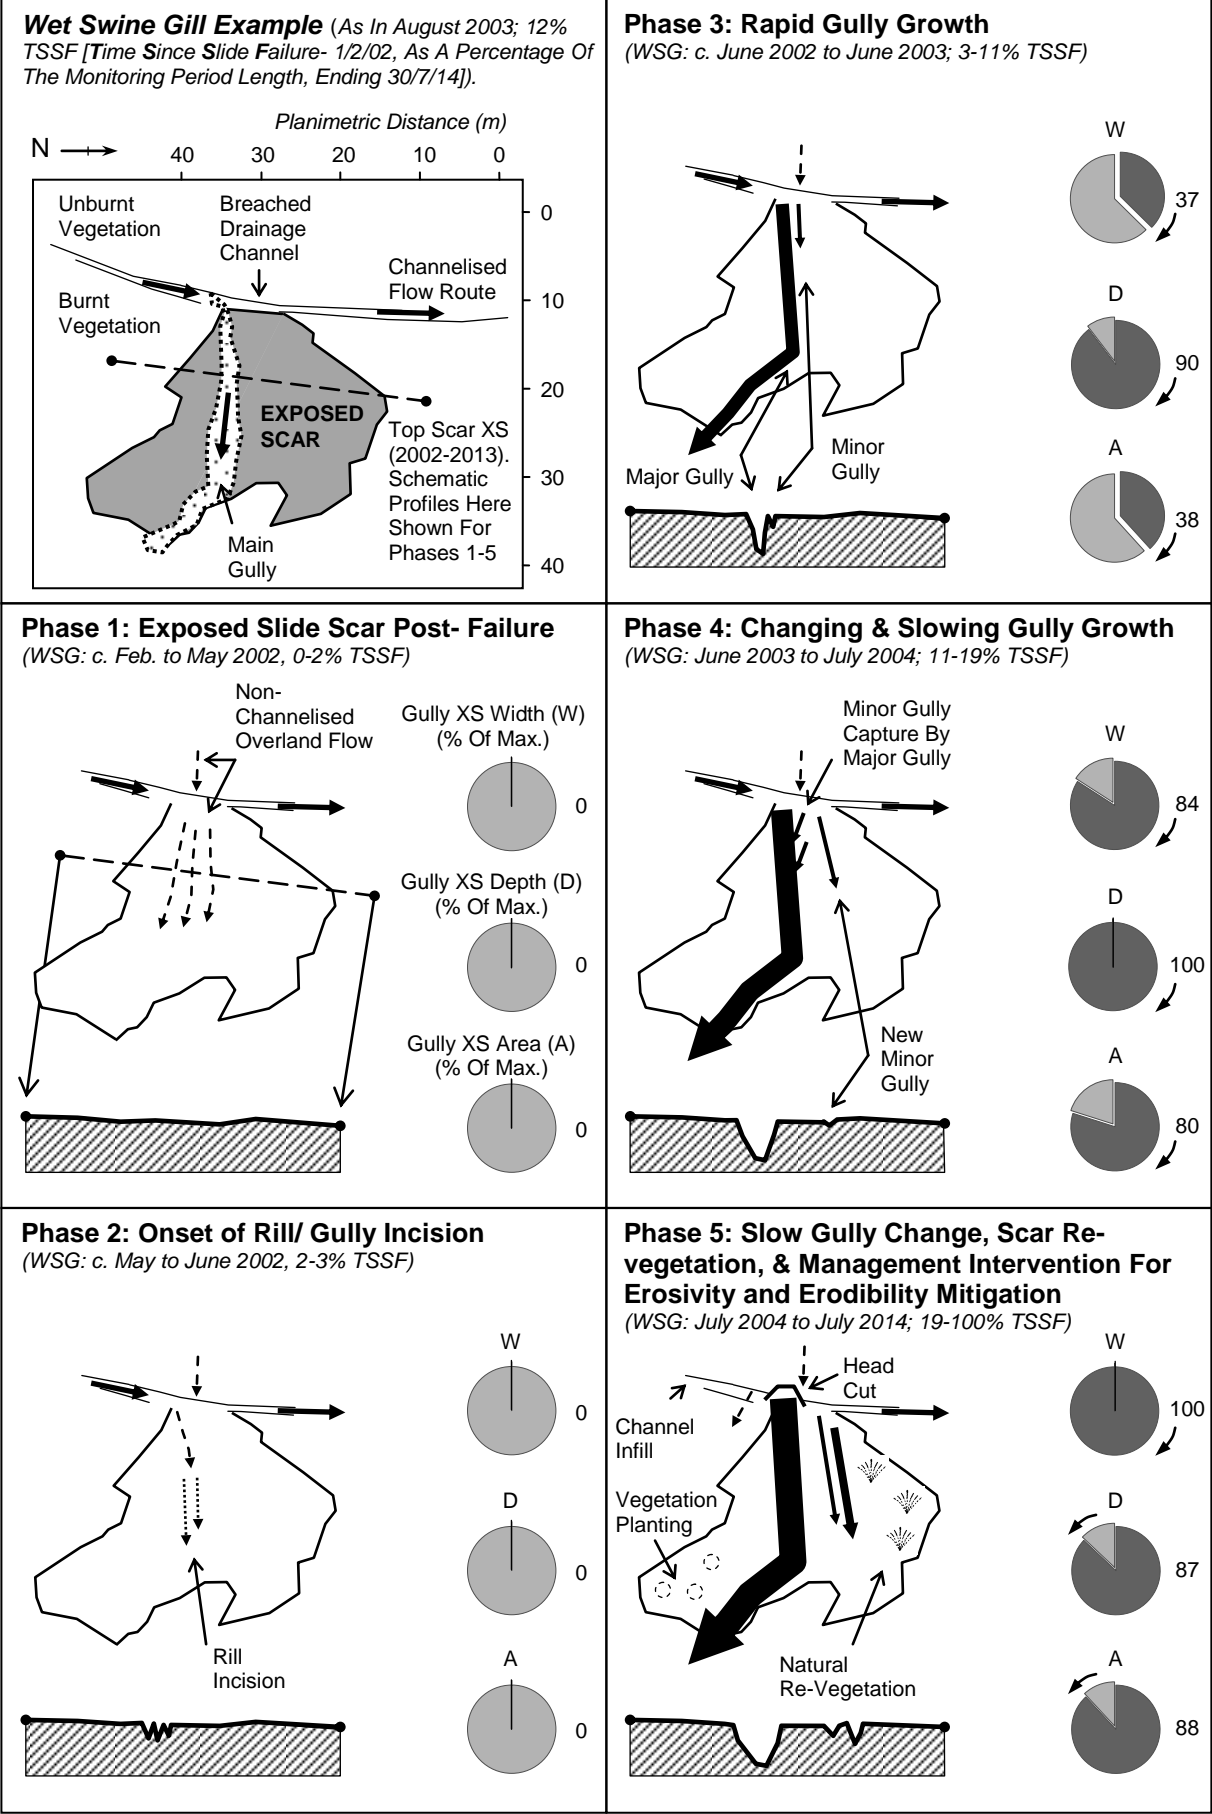
Fig 10

Figure 10 is a conceptual model for the post-failure development of a slide scar. This is based upon the Wet Swine Gill case study data between 2002 and 2014.

This model recognises five main phases, comprising: (1) post-failure scar exposure; (2) onset of rilling/ gully; (3) rapid gully growth; (4) changing and slowing gully growth; and (5) slowing gully change and scar re-vegetation. These phases outline key process activity, landform features and management interventions; each expressed with an indication of their relative longevity (being the time since slide failure [TSSF]) and the relative proportion and direction (clockwise= increasing to measured maximum; anti-clockwise= decreasing from measured maximum) of cross sectional change (here based on main gully top cross section dimensions at the end of each phase, except phase 5 which uses 2013 data [last measurement]). As established previously, these phases at Wet Swine Gill broadly conform to existing conceptual gully evolution models (i.e. Betts et al., 2003; Burkard and Kostaschuk, 1997; Harvey, 1992; Ireland et al., 1939; Kirkby and Bracken, 2009; Nachtergaele et al., 2002; Sidorchuk, 2006; Whitford et al., 2010). Indeed this history of scar development provides further support for the changing post-failure sediment budget at this site, as outlined by Johnson et al. (2010). Specifically, gully erosion of landslide scars increases hillslope sediment supply so that hillslope sources eventually dominate over stream channel sources in accounting for the majority of headwater sediment flux.

- Figure 10 Conceptual model of post-failure slide scar and gully development based upon the Wet Swine Gill case study.
- Table 1 Main gully size & shape 2002-2013 (A) Measured dimensions, (B) Percentage change between selected surveys/ attributes.
