## Nasty, Brutish and Short?; The Life Cycle of an Iron Age Roundhouse at Black Loch of Myrton, SW Scotland

Roundhouse; preservation; floor surfaces; occupation debris; short chronology; abandonment processes; life cycles

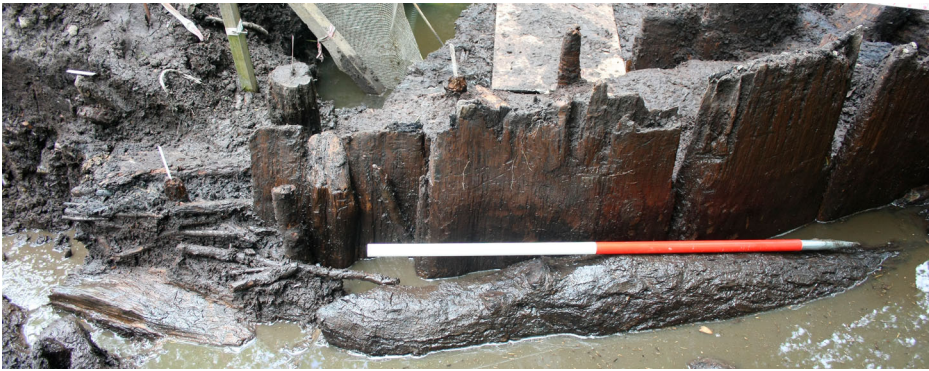
**Figure 3.** The oak plank façade to the left of the entrance. Courses of the wickerwork wall can be seen to the left, sitting just in front of the plank.

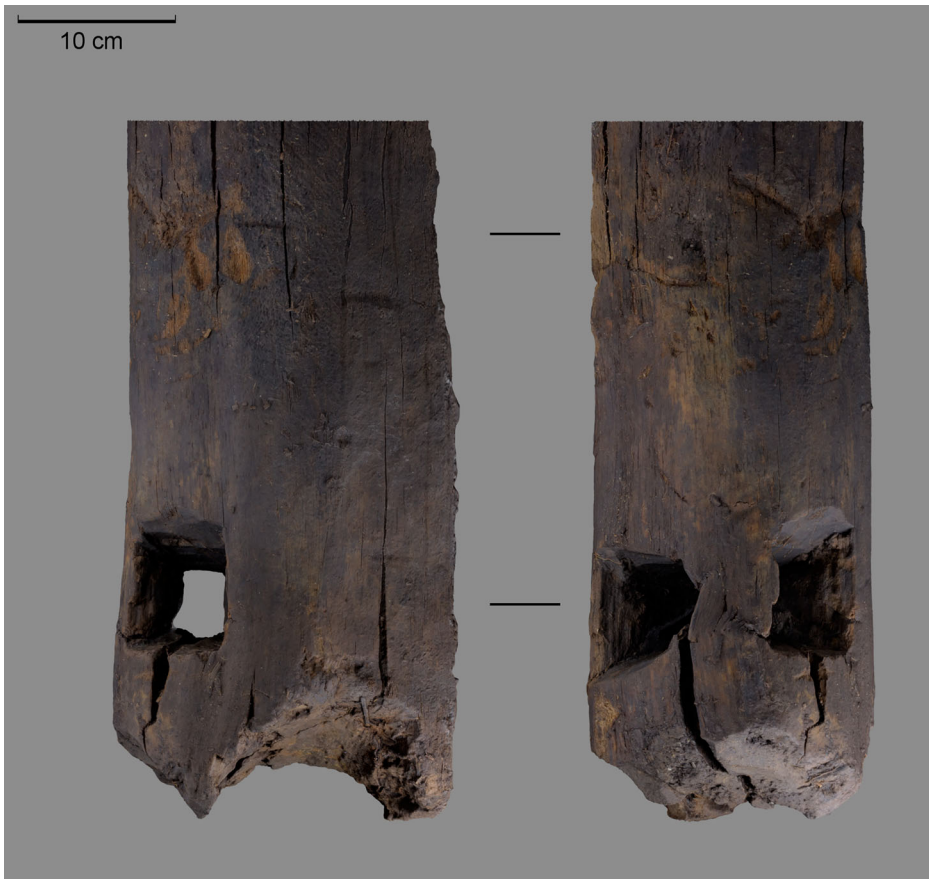
**Figure 4.** One of the oak posts of the outer post-ring displaying a concave base (orthographic view derived from photogrammetry). The roughly squared hole piercing one side of the post is a tow-hole which would have been used to drag the log from woodland to settlement. Many of the logs used in the settlement displayed these holes.

posts, of which six have been exposed. All the exposed posts have been fashioned from oak logs and all but one display concave bases which were presumably designed to fit over the radial logs of the sub-floor (Figure 4).

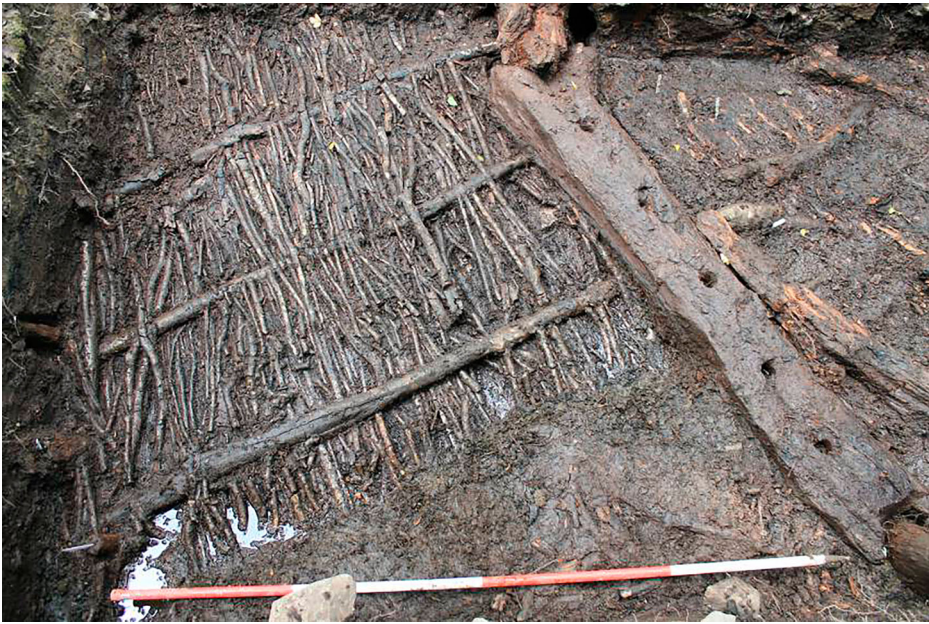
**Figure 5.** Sillbeam 223/1 *in situ* displaying stake holes and jointing around the posts. The stakes of the outer wall are visible to the left. The wickerwork screens formed the sub-floor of the Phase 1 building.

In between each post pair was a large alder sillbeam which had been laid directly over the wickerwork sub-floor. Most of these timbers were too decayed to preserve original carpentry details but the best-preserved example had been roughly squared, with five stake-holes cut along its length and shaped at either end to fit snugly around the upright posts, utilising a branch junction at one end to form this joint (Figure 5). These sillbeams would have created a major concentric division within the building (see below) but like the concave posts, they would have left no earthfast footprint.

#### *Associated Surfaces (Figures 5 and 6)*

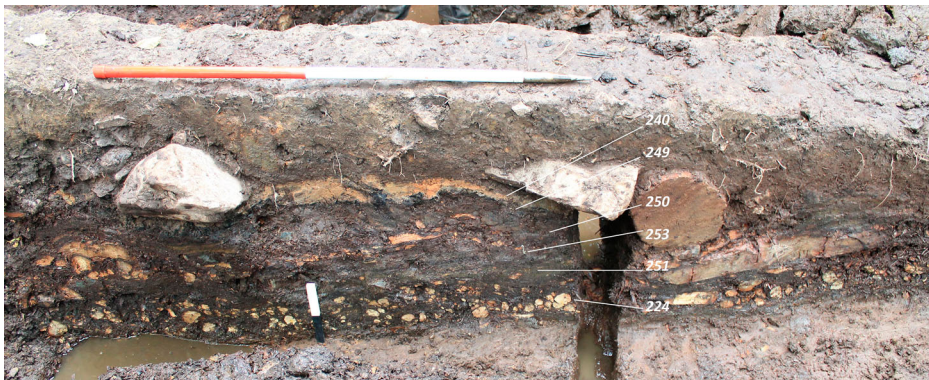
**Figure 7.** The full sequence of floor structures and surfaces is visible in this section. The Phase 1 wickerwork sub-floor lies at the base of the section, over the natural peat. Above this is [251], the plant litter floor surfaces, seen here as a grey-green layer. The Phase 2 brushwood sub-floor lies over this, followed by [250], the plant litter floors of this phase. The carbonised upper surface of this floor is visible, as is the orange clay laid immediately over it in Phase 3. The light brown peaty clay which covered the trench probably contains the mineralised remains of later organic floors belonging to this phase.

Immediately overlying [250] in large patches within the post-ring was a layer of carbonised plant litter between 0.03 and 0.04 m thick which is probably the burnt upper surface of [250] (Figure 7 – context 249). The survival of considerable quantities of charcoal, charred and reddened plant and fine mineral material suggests a relatively low temperature fire. It seems most likely that a spillage from the hearth caused the fire, which was prevented from spreading into the outer area beyond the post-ring by a screen of some sort. This conflagration probably brought this phase of activity in the house to an end.

In the final refurbishment of the house, the hearth was reduced to approximately half its original area from *circa* 7 m<sup>2</sup> in Phase 2–3.5 m<sup>2</sup> (Figure 7). A loosely constructed kerb of stones was laid just within and over the existing Phase 2 timber framework and a layer of clay, flecked with charcoal and burnt bone was spread over the surface area within the timber framework to form the foundation for Hearth 2. Within this outer kerb a line of four large oval boulders formed an inner kerb around the S edge which may have originally encircled the hearth and within this large greywacke slabs formed the working surface (Figures 7 and 10).

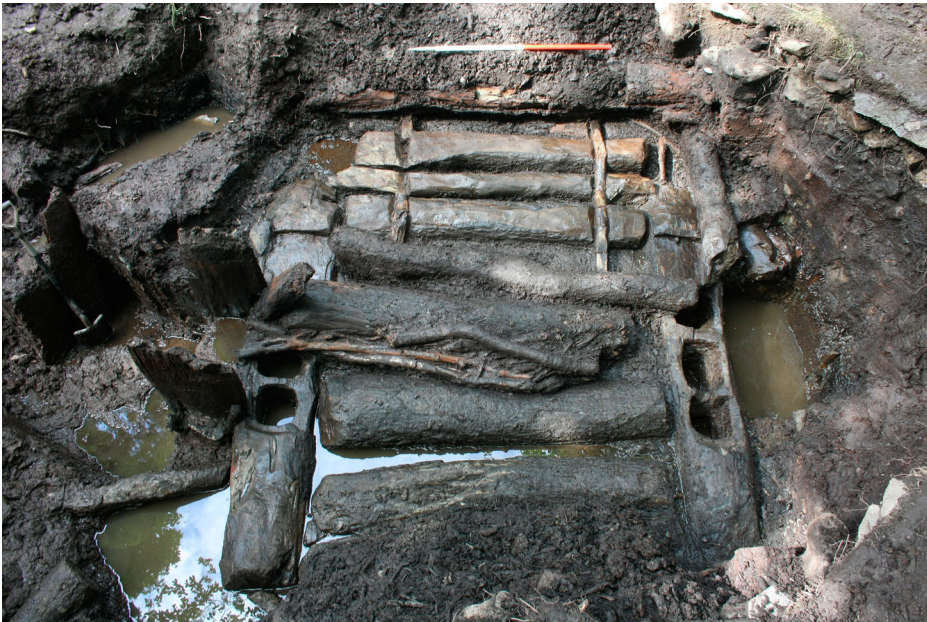
**Figure 8.** The Phase 1 entrance structure, looking into the building, with the oak planks of the outer wall still *in situ* where they abut the entrance.

The sides of the primary entrance structure were defined by two large radial logs 2.2 m long and set 1.70 m apart (Figures 2 and 8). A row of three closely-set mortices penetrated both logs, just at the point where the outer wallfaces met the entrance; these housed squared oak posts which would have formed the terminals of the outer wall and also lined the passage into the house. The inner ends of these radial sleeper beams had been dressed flat but the outer ends had not been worked, the bark still in place.

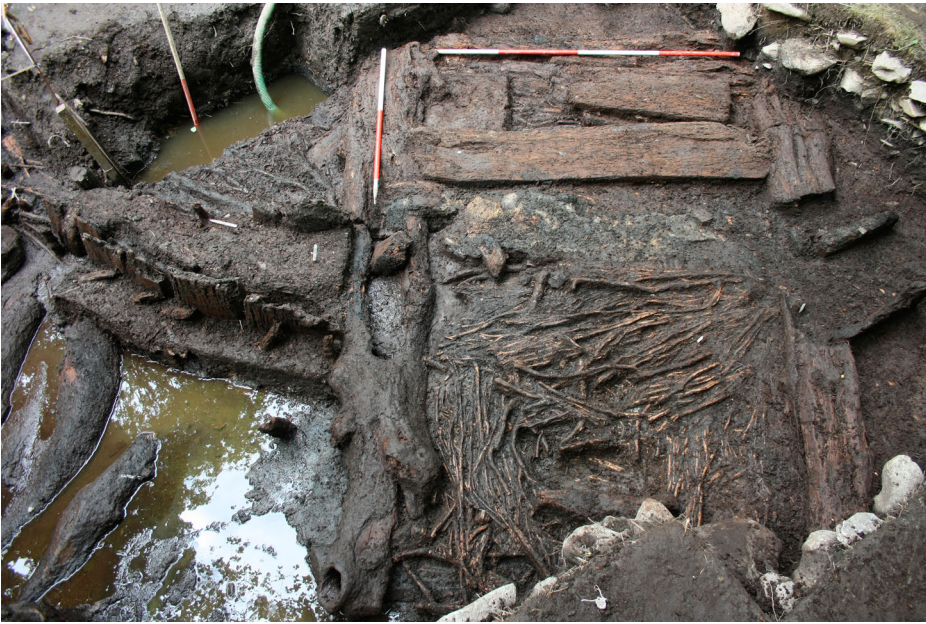
**Figure 11.** The Phase 2 entrance structure, looking into the building.

This framework was much more shoddily built than the Phase 1 entrance. New radial logs were laid directly over the Phase 1 logs (Figure 11). These radials were fashioned from undressed half-logs of alder, the curved surface of the log uppermost; it is possible that they are the two halves of the same log.

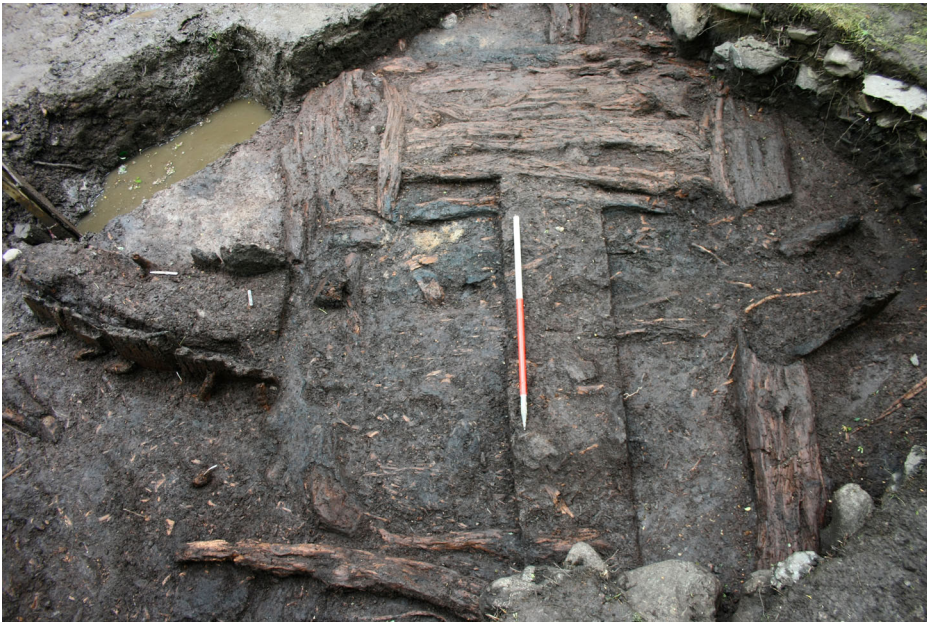
**Figure 12.** The Phase 3 entrance structure, looking into the building.

The final phase in the entrance area consisted of resurfacing rather than reconstruction and probably happened rapidly after Phase 2 because the new surfaces lay directly over the earlier ones with no evidence for any build-up of debris. The resurfacing consisted of a rectangular area of small alder logs, a 'welcome mat', which had been laid directly over the oak plank surface of the previous entrance (Figure 12). It was 2.2 m by 1.4 m, and was defined by two radial logs between which a continuous surface of tangential logs had been laid.

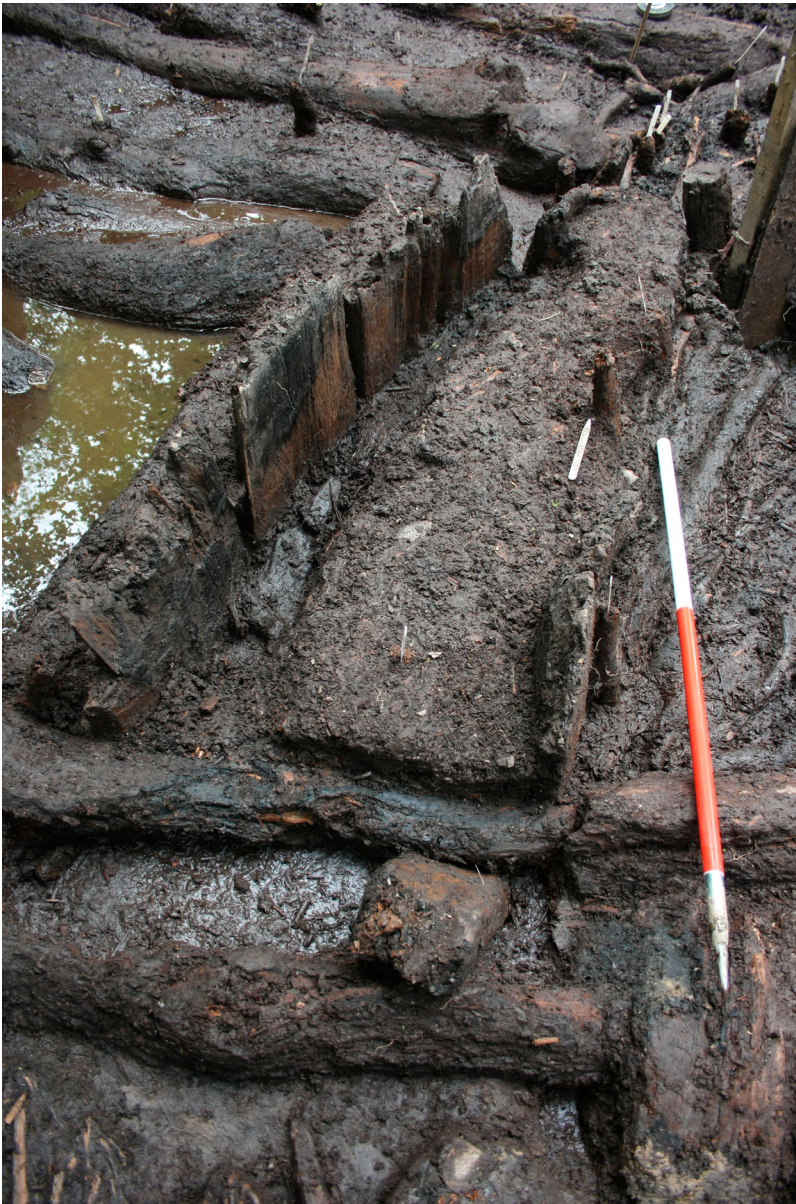
**Figure 15.** The plank walling of the outer wall at its junction with the entrance. Charring on the inner faces is visible. In the foreground the radial defining the lefthand side of the entrance is also clearly charred.

The bases of the posts and walls had obviously remained *in situ* so the structure was not entirely dismantled but there is evidence to suggest that a controlled burning event may have signalled the end of its life. The tops and inner faces of the planks on both sides of the entrance, as well as the tops of the posts in the eastern entrance terminal, were all charred, as was the radial log forming the eastern side of the Phase 2 entrance at its junction with the plank wallfaces (Figure 15). Within the cavity of the outer wall there were large quantities of carbonised withies, brushwood and plant remains. There is no evidence of burning within the interior or the entrance, apart from the charred tops of a few Phase 3 timbers and some of the trackway logs abutting the outer wall. This suggests that fires may have been set and contained within the outer wall. It also implies that, by the time the fire was started, the roof and the upper parts of the walls and posts had either been removed or had rotted down because there is no evidence, in the form of a charcoal horizon across the footprint of the house, to suggest that there had ever been a major conflagration. At one of the Iron Age farmsteads on the Assendelvers Polders in the Netherlands, some of the roof supports had been chopped off prior to abandonment, presumably to salvage usable timber (Therkorn et al. 1984, 365). The authors pointed out there that the roof would have had to have been dismantled before this could happen and this could also have occurred at Black Loch.
