Full-Scale Fatigue Testing of a Wind Turbine Blade in Flapwise Direction and Examining the Effect of Crack Propagation on the Blade Performance

Othman Al-Khudairi ¹, Homayoun Hadavinia ^{1,*}

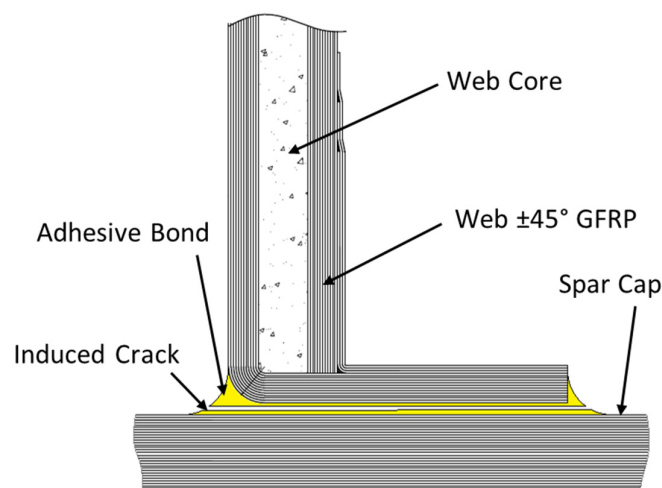
Figure 1. Schematic of induced crack location.

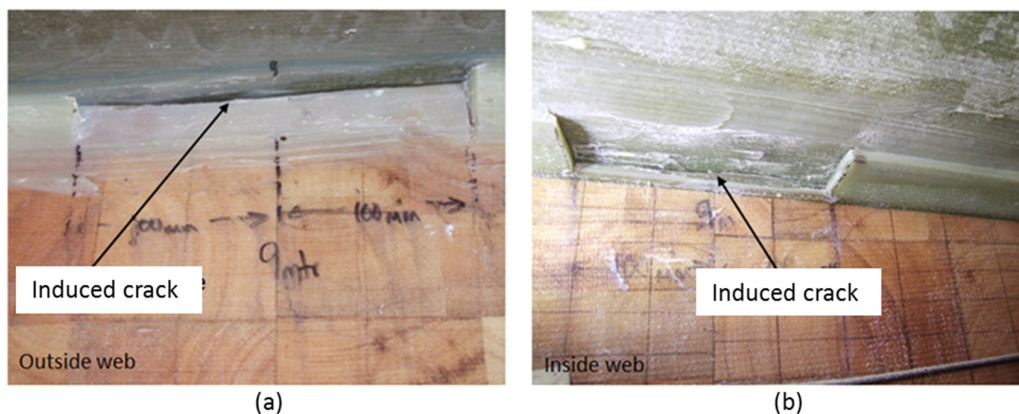
A 200 mm crack was created by cutting the adhesive bond between the shear web and spar cap at 9 m from the blade root. Figure 6a shows the crack from outside and Figure 6b shows the crack from inside of the shear web box. Four AE sensors were fitted on the shear web wall to monitor the crack growth and to understand its behaviour during cyclic loading.

Figure 6. Creating a 200 mm crack at 9 m from the root. View from (a) outside and (b) inside of the shear web box.

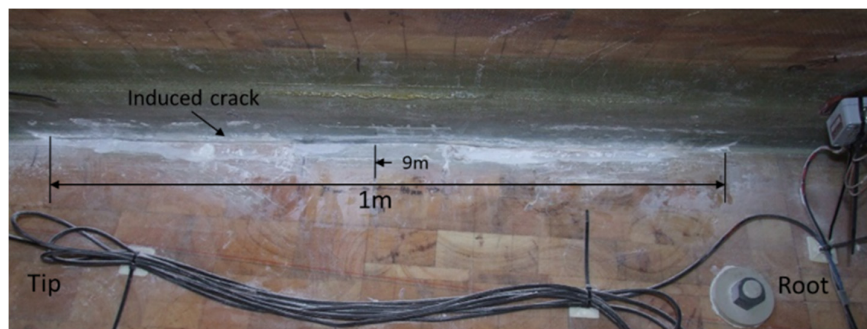
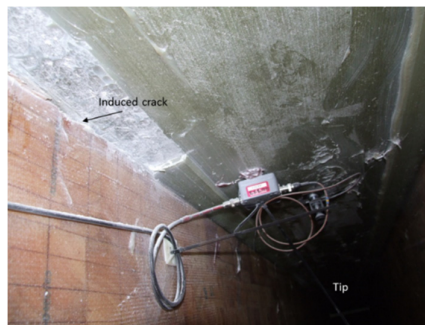
The blade structural response to crack propagation was studied further by extending manually the 200 mm crack after calibration, modal and fatigue test to 1000 mm. The centre of de-bonded crack was kept unchanged at 9 m from the blade root and it was extended symmetrically from both sides as shown in Figure 7.

Figure 7. Extension of the crack to 1000 mm at 9 m from the blade root. View from (a) outside of the shear web box; (b) from inside of the shear web box.
